TfL - Buses Investigation of Major Incident Form

1.1	IRIS Ref	LAF/24/0098AF
1.2	Operator reference	LAF/24/0098
1.3	CAD Number (where applicable)	
1.4	Incident type (e.g. bus vs pedestrian, bus vs car etc.)	Bus Fire

1.10	Summary of incident	<p>Fleet number SEe232 (electric bus) caught fire inside Putney Garage on the 24th of January at around 0819hrs when the bus was parked inside the garage (out of service)</p> <p>The night before 23.01.24 at around 23:47hrs a Route 265 driver reported that SEe232 was not moving and it was subsequently towed around eight miles from the Tolworth area and deposited outside Putney Garage, which was full overnight.</p> <p>After garage run-out was complete on 24.01.24, Putney Garage engineers used a 24V boost pack to move vehicle SEe232 inside the garage, where it was parked on designated bay and put on charge. Approximately 8min later, black smoke and sparks were observed coming from the front end of the vehicle. A garage engineer took the bus off charge, isolated the charger, raised the alarm and helped to safely evacuate the building and Fire Brigade were called.</p> <p>On attendance the LFB extinguished the fire, the manufacturer BYD engineers att

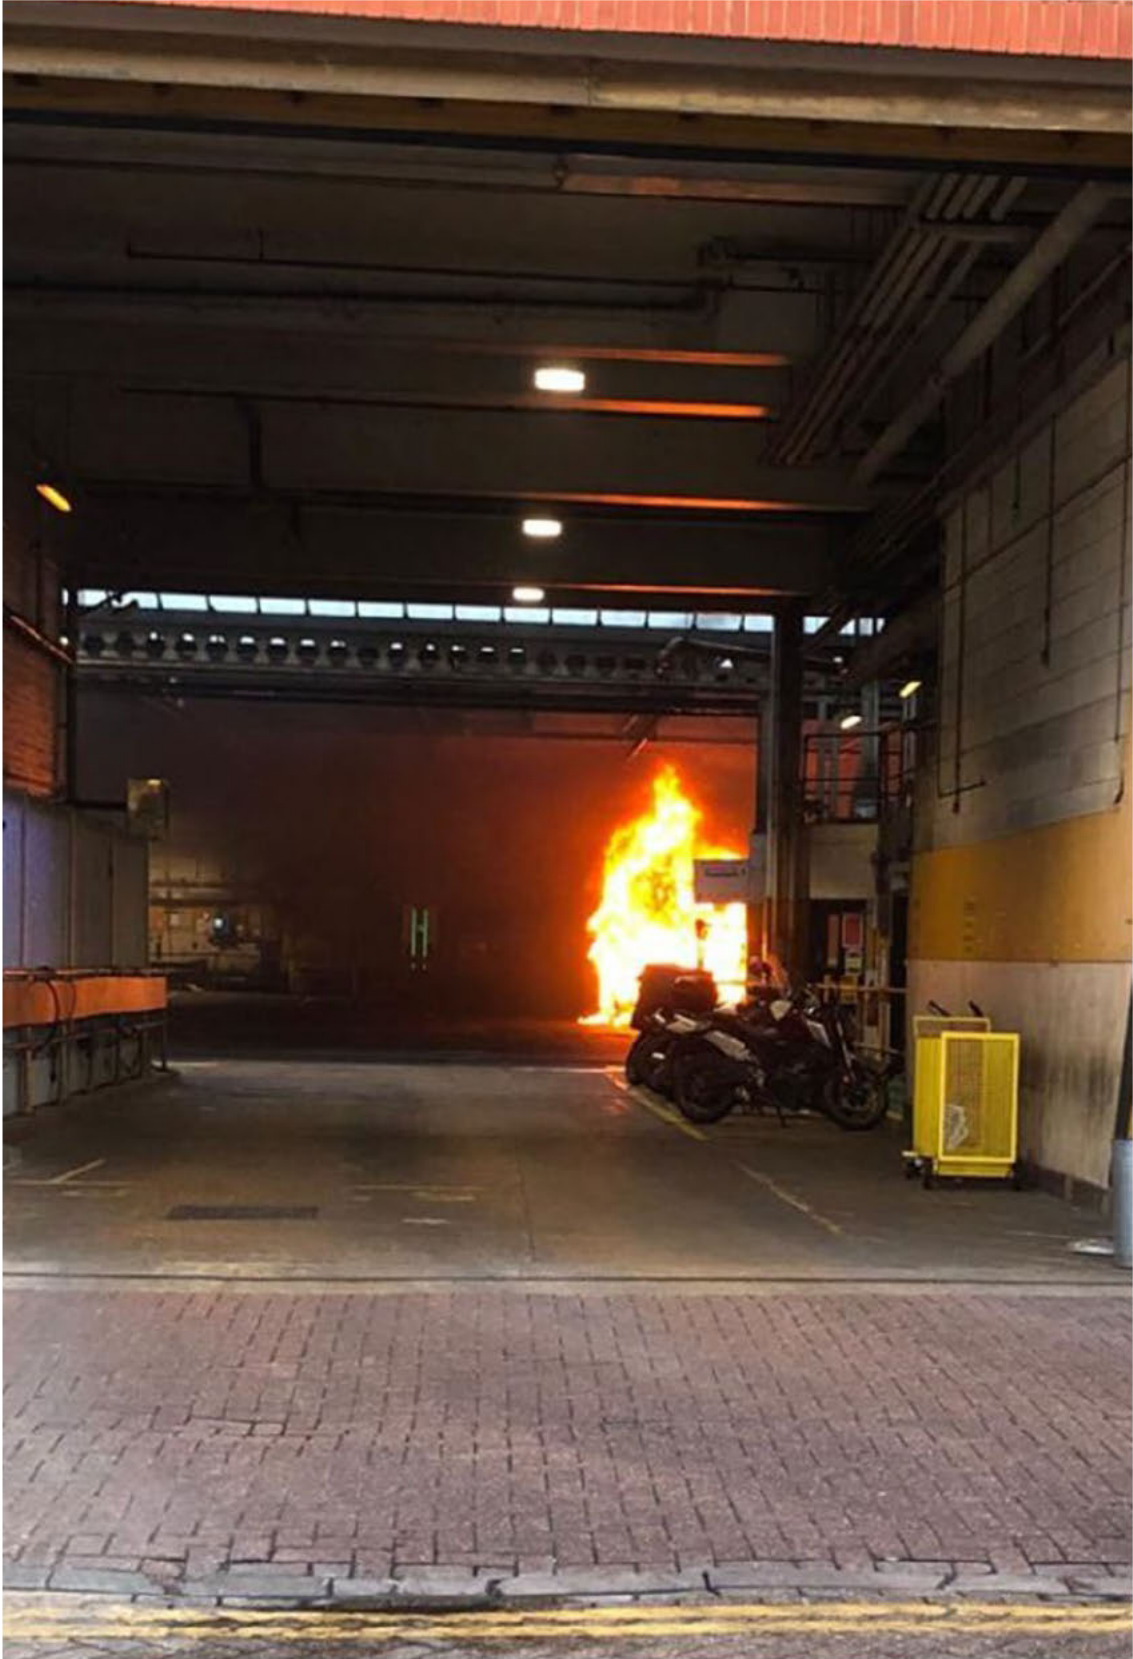
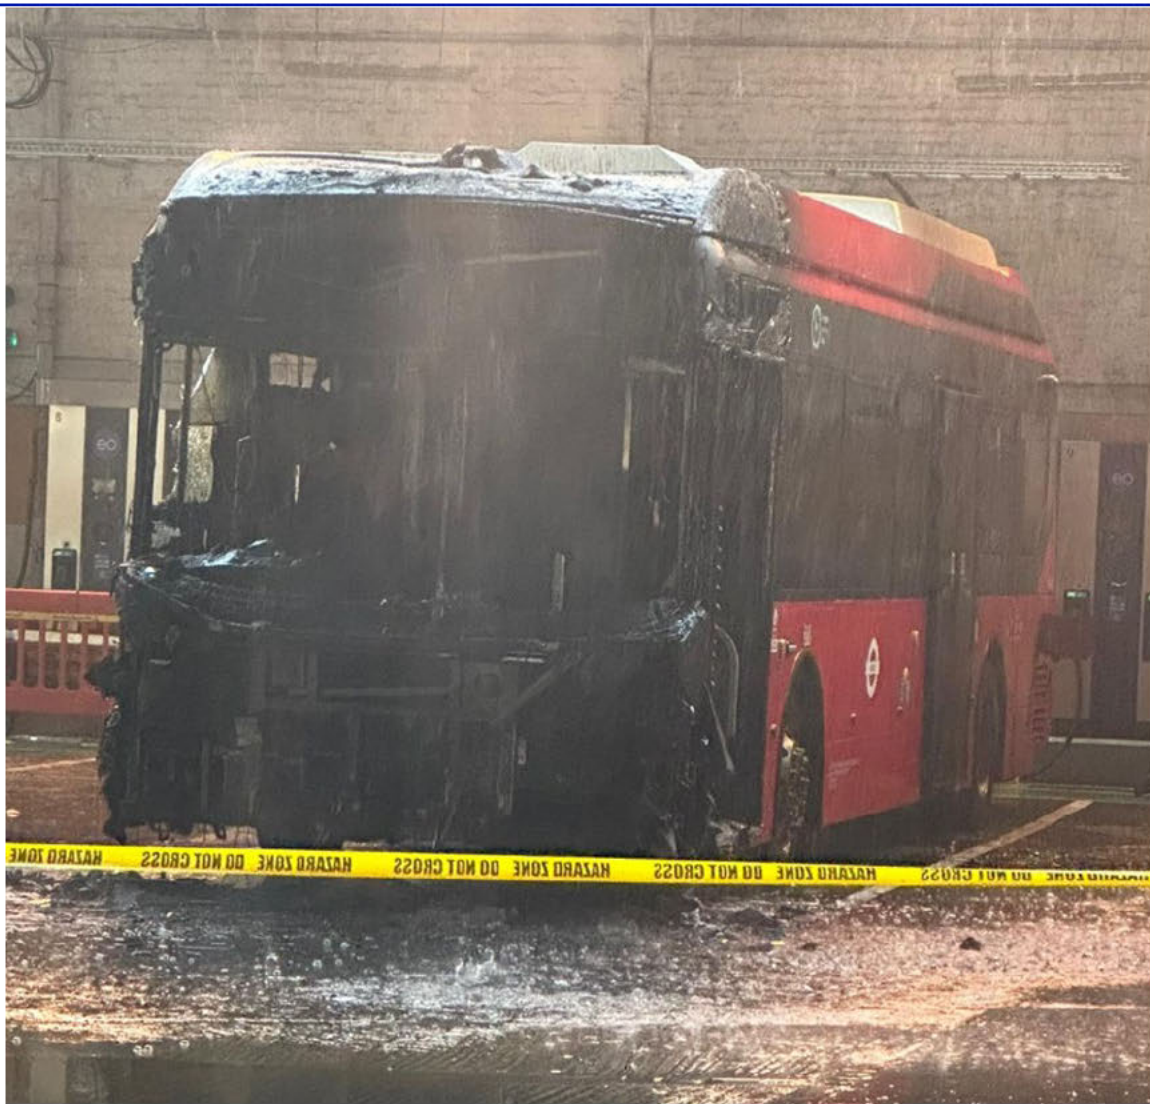
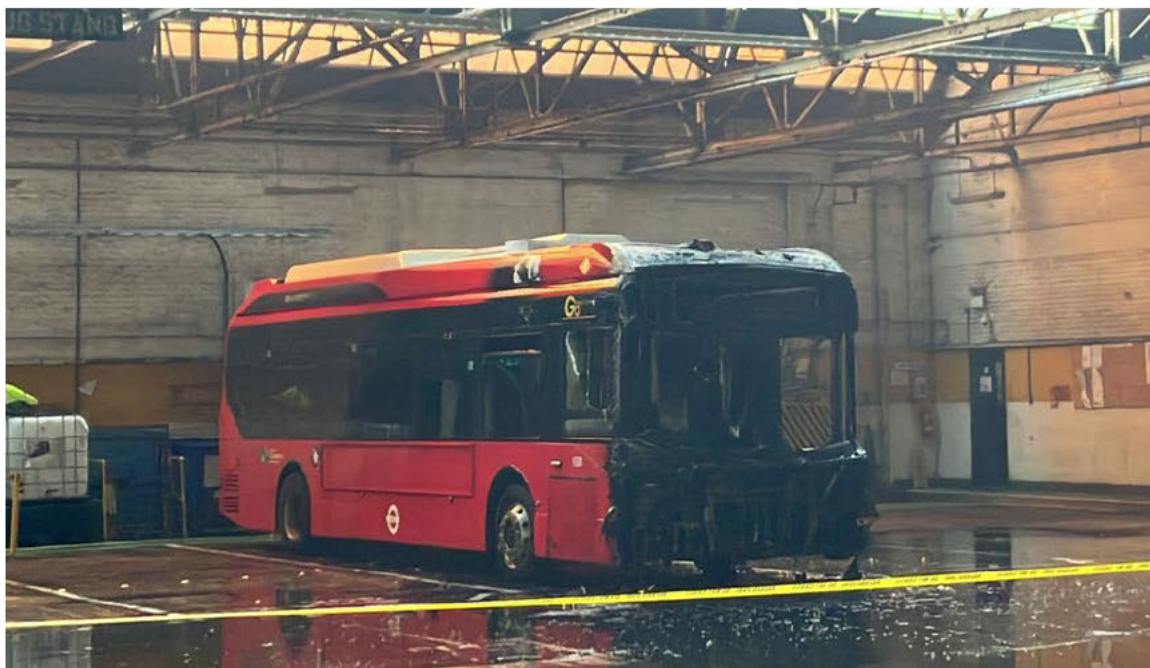
8.2

Time	Event
08:19	Cloud of smoke appear from the front of the bus
08:23	Front of the bus is in flames
08:30	LFB arrived on site

6.2	<p>Steps to be taken to reduce likelihood of recurrence (Operator)?</p>	<p>An instruction has gone out from the manufacturer to bus operators to not disable the buses HVAC in the event the bus will not start up.</p> <p>Putney fire, solution from AD</p> <p>Physical Changes</p> <ul style="list-style-type: none"> • [REDACTED] • Warning label from service bulletin 966-2 fitted to isolator box will remain in place, the information is key as a reminder of correct operation. • [REDACTED] • Install new Hispacold control software to introduce the control changes detailed below. <p><u>Control Changes – Applies to the control of all heating elements in the HVAC system (Demist, Saloon Evaporator, and Saloon Condenser)</u></p> <p>If a contactor auxiliary contacts are closed when not commanded, OR Excessive Heat is detected via sensors local to the element, then:</p> <ul style="list-style-type: none"> • Run appropriate blower fan at 100% to maintain the element at a safe temperature • Prevent drivers controls from adjusting fan speed (Demist) • Prevent driver from turning system off using controller 'Auto' switch (Demist) • Open fresh air flaps (no recirculation) • Display fault on driver's HVAC controller • De-energise all contactor coils <p>Notes</p> <p>[REDACTED]</p> <p>Monitoring of the auxiliary contacts will be continuous when the HVAC system is powered, the integrity of the monitor circuit will be checked at each start up.</p>

6.3	Steps to be taken to reduce likelihood of recurrence (TfL)?	N/A
6.4	Actions by third parties (e.g. vehicle manufacturer, local borough etc.) that could reduce the likelihood of recurrence	<p>Investigated with the BYD and ADL.</p> <p><u>Physical Changes</u></p> <p>[REDACTED]</p> <p>Warning label from service bulletin 966-2 fitted to isolator box will remain in place, the information is key as a reminder of correct operation.</p> <p>[REDACTED]</p> <p><u>Control Changes – Applies to the control of all heating elements in the HVAC system (Demist, Saloon Evaporator, and Saloon Condenser)</u></p> <p>If a contactor auxiliary contacts are closed when not commanded, OR Excessive Heat is detected via sensors local to the element, then:</p> <ul style="list-style-type: none"> Run appropriate blower fan at 100% to maintain the element at a safe temperature Prevent drivers controls from adjusting fan speed (Demist) Prevent driver from turning system off using controller 'Auto' switch (Demist) Open fresh air flaps (no recirculation) Display fault on driver's HVAC controller De-energise all contactor coils <p><u>Notes</u></p> <p>[REDACTED]</p> <p>Monitoring of the auxiliary contacts will be continuous when the HVAC system is powered, the integrity of the monitor circuit will be checked at each start up.</p>
